Roof refurbishment from the outside | Pitched roof | Bargeboard, 'sub-and-top' installation, Var.1

Roof refurbishment from the outside | Pitched roof | Bargeboard, 'sub-and-top' installation, Var. 2

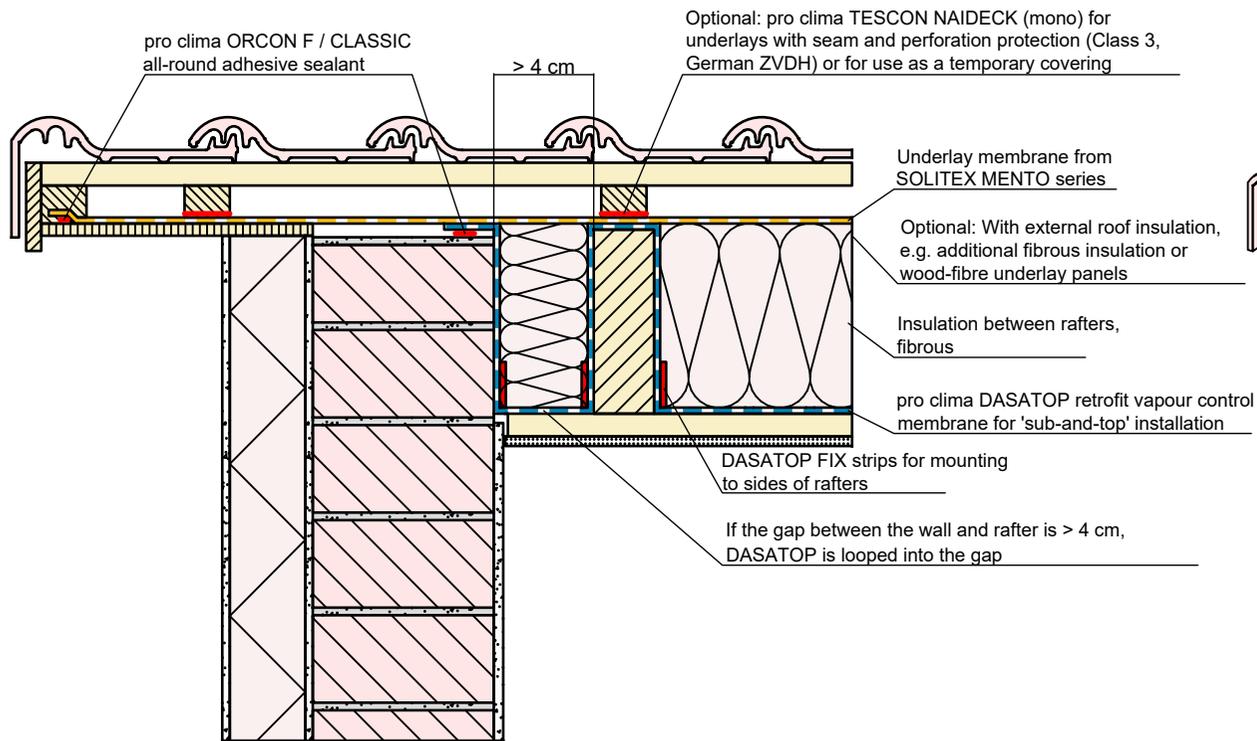
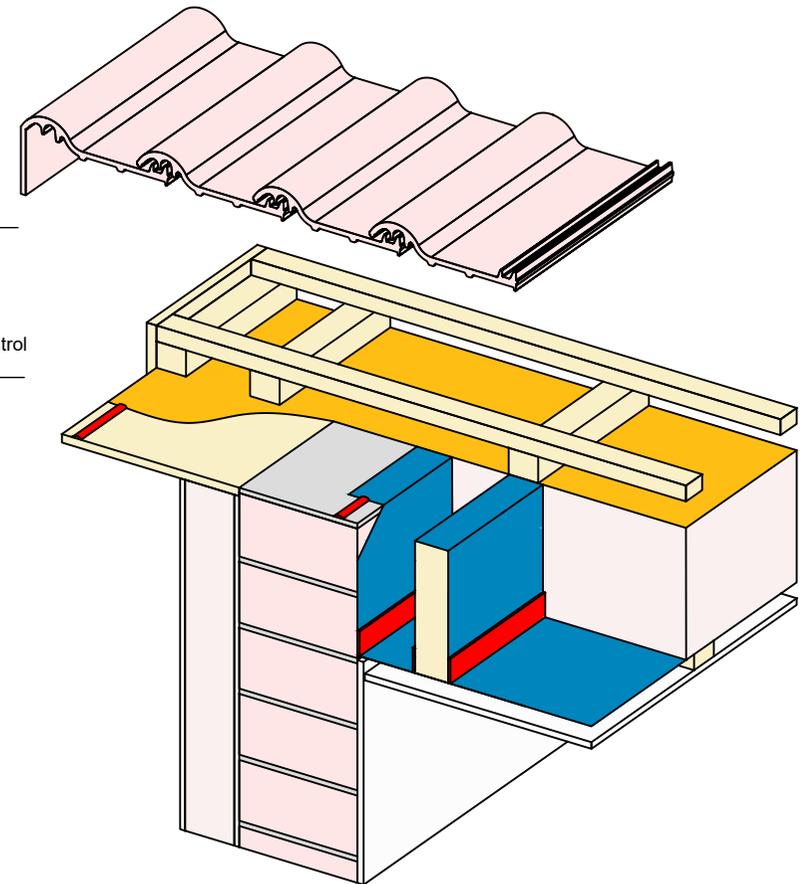
DASATOP retrofit membrane installed from the outside using 'sub-and-top' method. Fixed to the sides of the rafters using DASATOP FIX strips.

Typical structural situation to illustrate the airtightness and windtightness layers. When carrying out planning and performing installation on site, please observe the currently applicable technical regulations and the relevant pro clima recommendations for applications and installation (German version: 05/22; international version: 03/26).

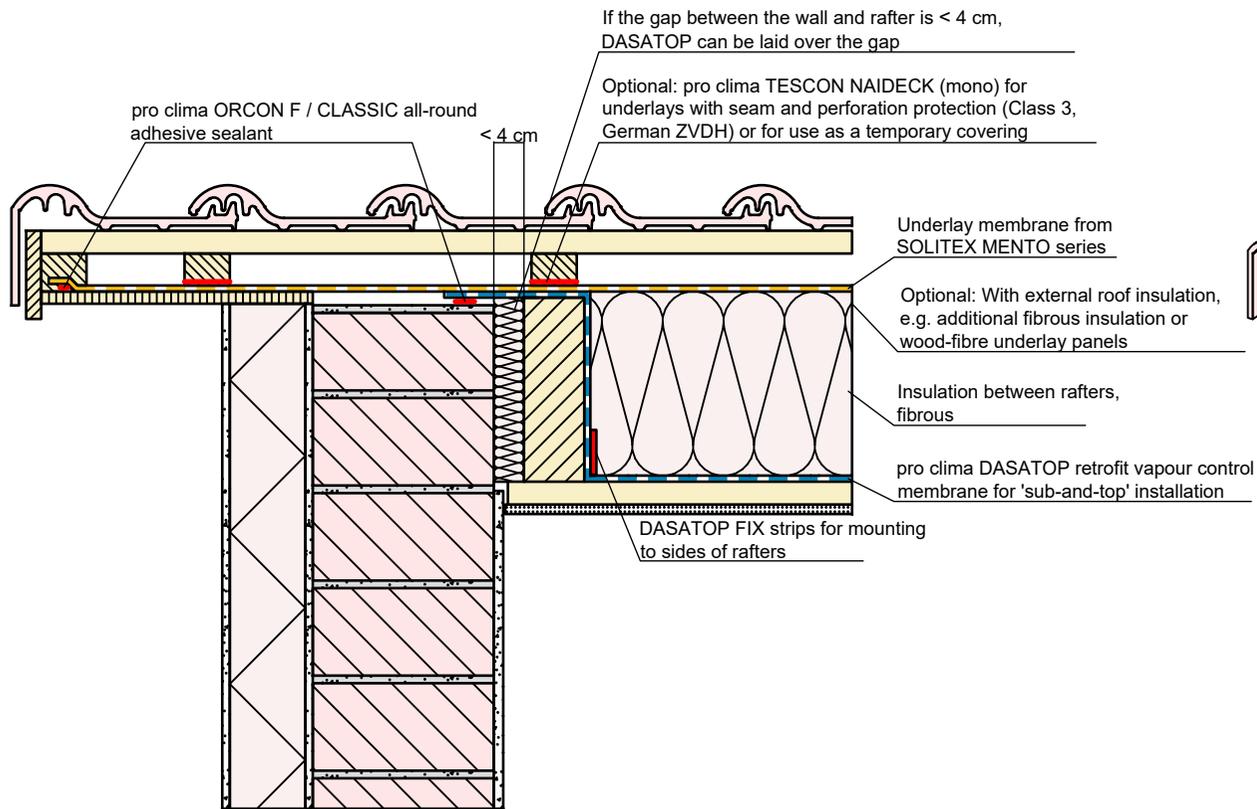
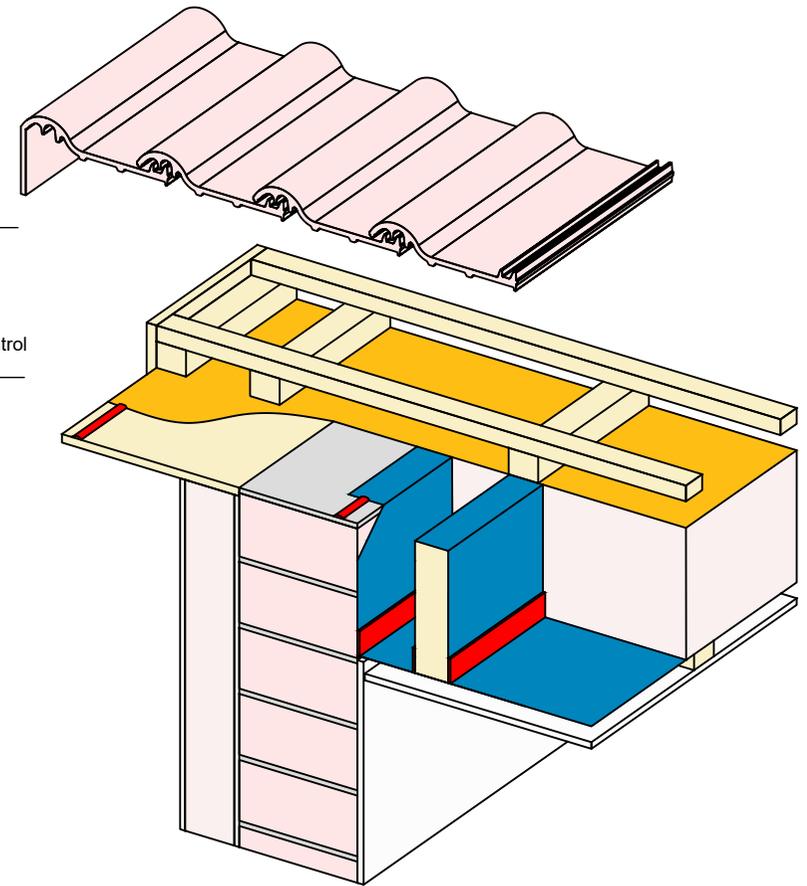
DASATOP retrofit membrane installed from the outside using 'sub-and-top' method. Fixed to the sides of the rafters using DASATOP FIX strips.

Typical structural situation to illustrate the airtightness and windtightness layers. When carrying out planning and performing installation on site, please observe the currently applicable technical regulations and the relevant pro clima recommendations for applications and installation (German version: 05/22; international version: 03/26).
