Roof refurbishment from the outside | Pitched roof | Eaves, 'sub-and-top' installation, Var.1

DASATOP retrofit membrane installed from the outside using 'sub-and-top' method. Variant 1: With existing rafters with rafter tails

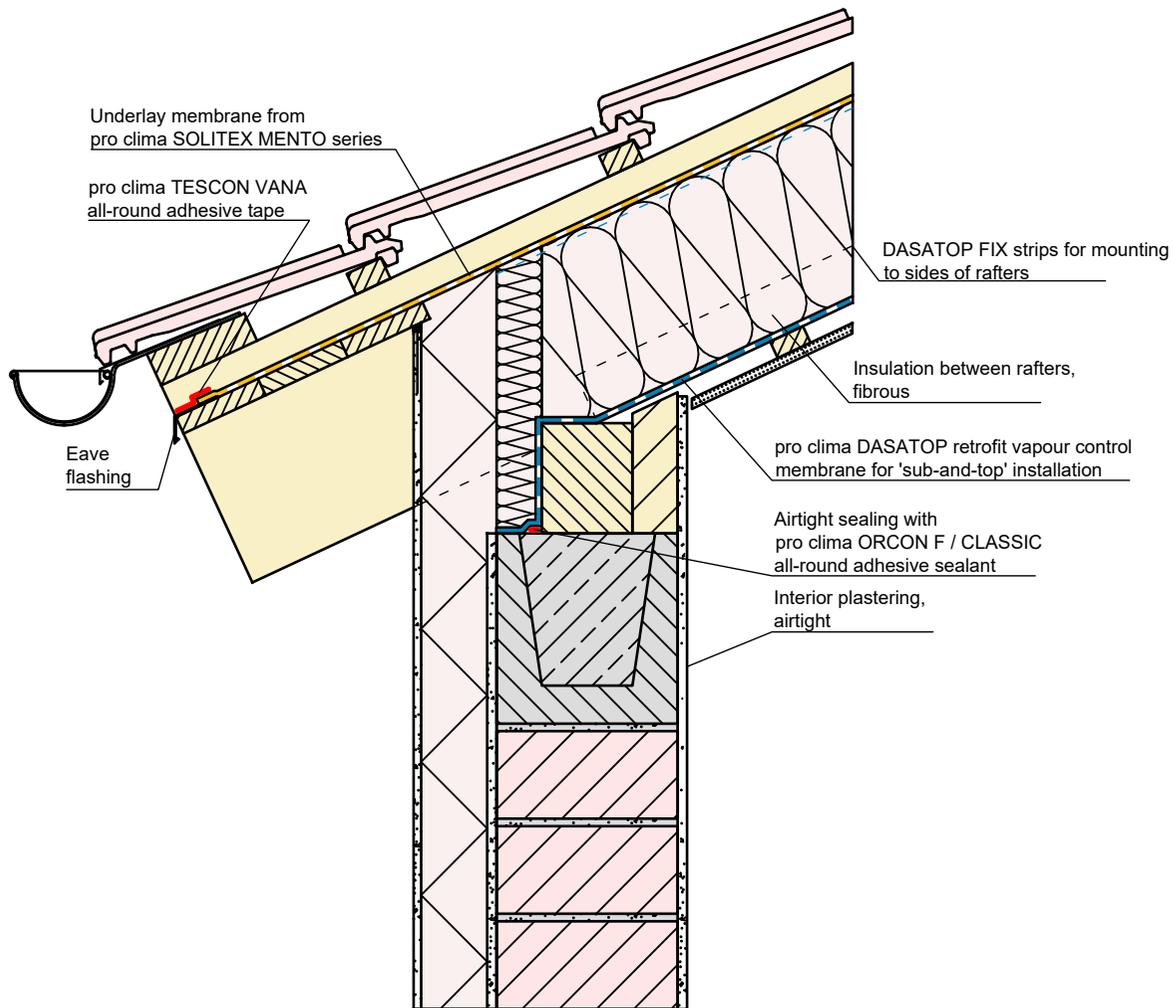
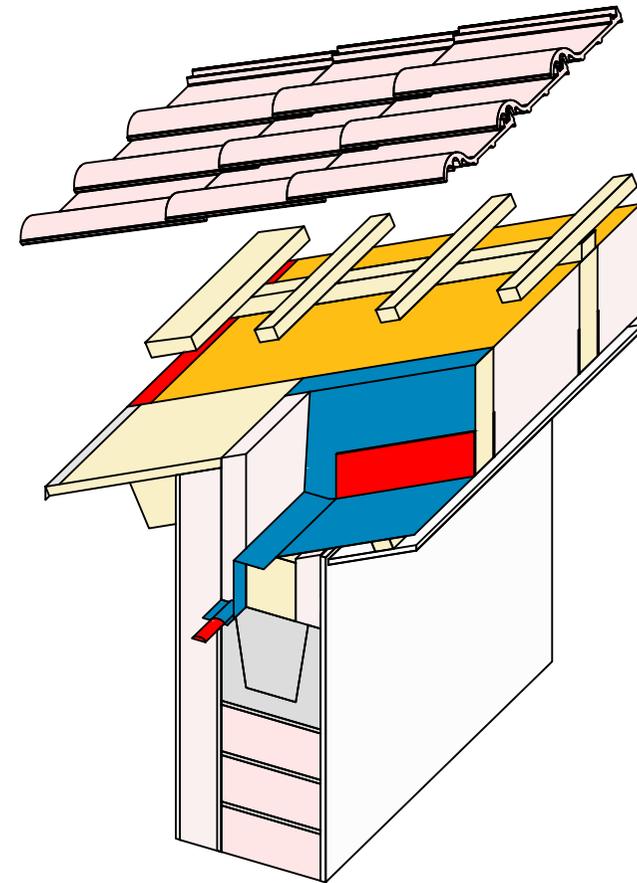
Typical structural situation to illustrate the airtightness and windtightness layers. When carrying out planning and performing installation on site, please observe the currently applicable technical regulations and the relevant pro clima recommendations for applications and installation (German version: 05/22; international version: 03/26).

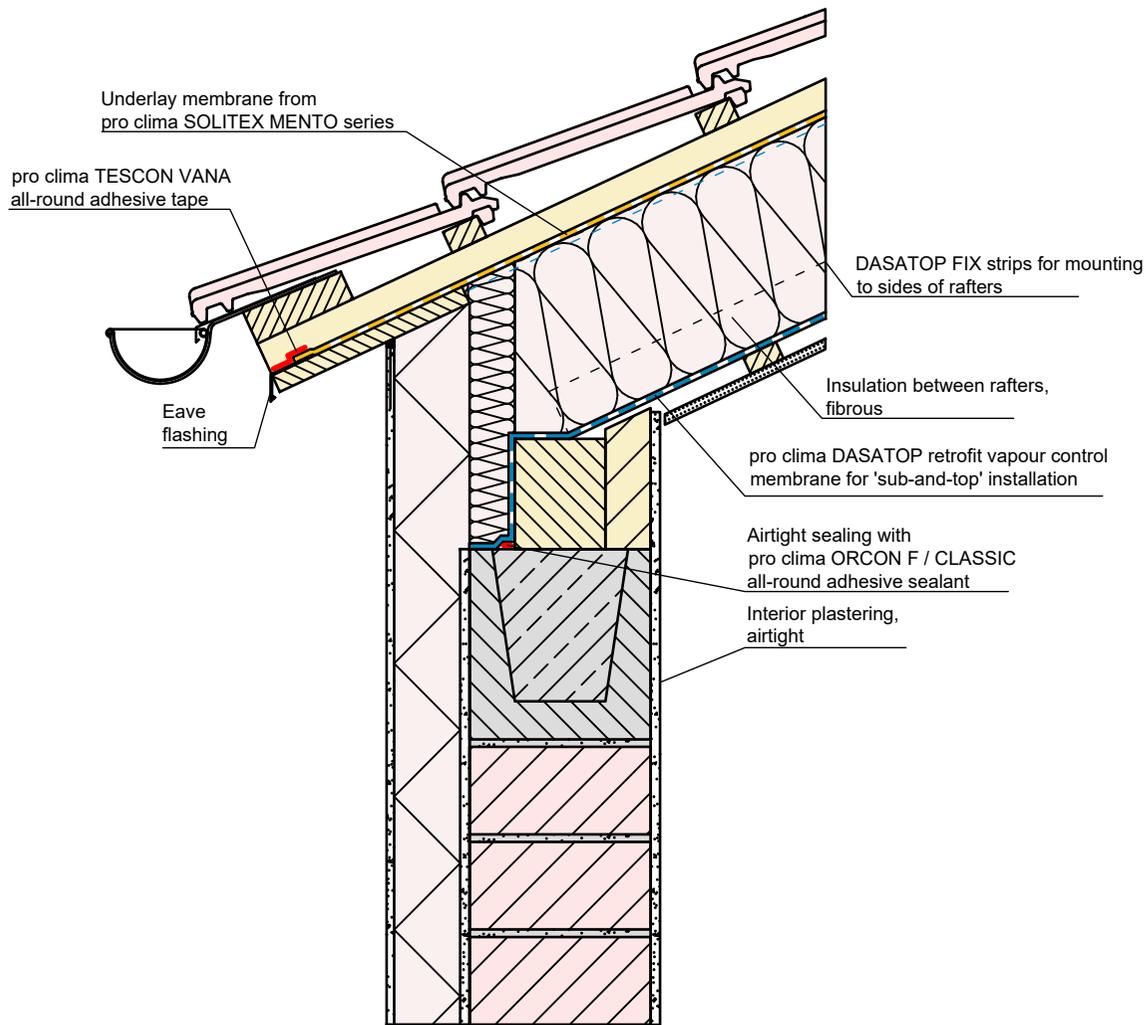
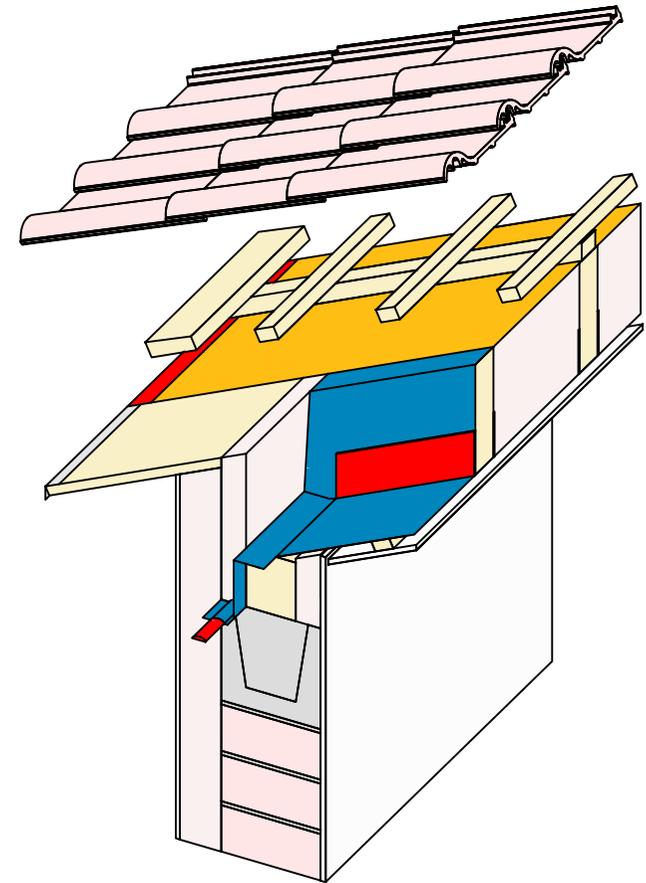
Roof refurbishment from the outside | Pitched roof | Eaves, 'sub-and-top' installation, Var. 2

DASATOP retrofit membrane installed from the outside using 'sub-and-top' method. Variant 2: With truncated existing rafters

Typical structural situation to illustrate the airtightness and windtightness layers. When carrying out planning and performing installation on site, please observe the currently applicable technical regulations and the relevant pro clima recommendations for applications and installation (German version: 05/22; international version: 03/26).
