# Roof refurbishment from the outside | Pitched roof | Chimney, 'sub-and-top' installation, Var.1

DASATOP retrofit membrane installed from the outside using 'sub-and-top' method.

## Roof refurbishment from the outside | ROFLEX und KAFLEX with 'sub-and-top' installation

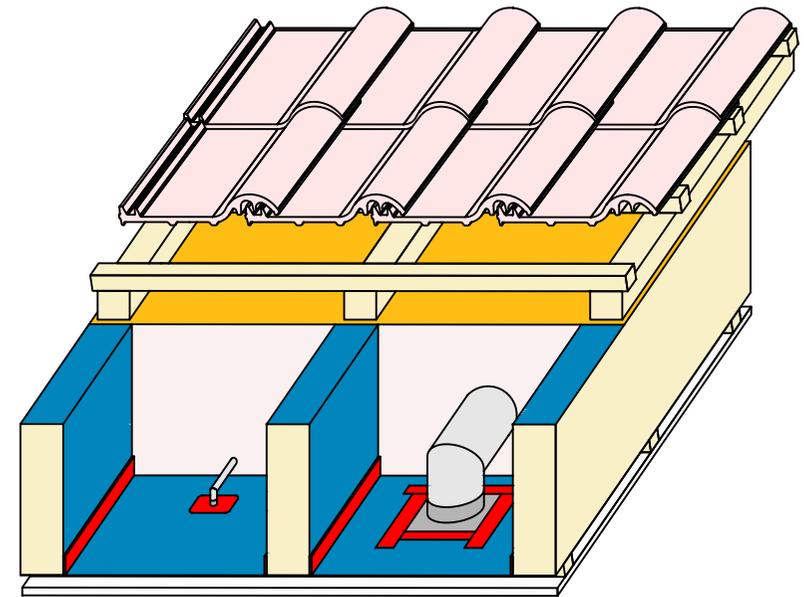
Airtight sealing of cable and pipe feed-throughs with pro clima KAFLEX and ROFLEX grommets.
